OSID-Range - Erratum

February 2021

Conventional: OSI-R, OSI-RA, OSI-R-SS, OSI-RA-SS

Intelligent: OSI-RI-SS, OSI-RIA-SS, OSI-RI-FL, FS-OSI-RI, FS-OSI-RIA, OSI-RI-FH, OSI-RI-GW, OSI-RI-SK

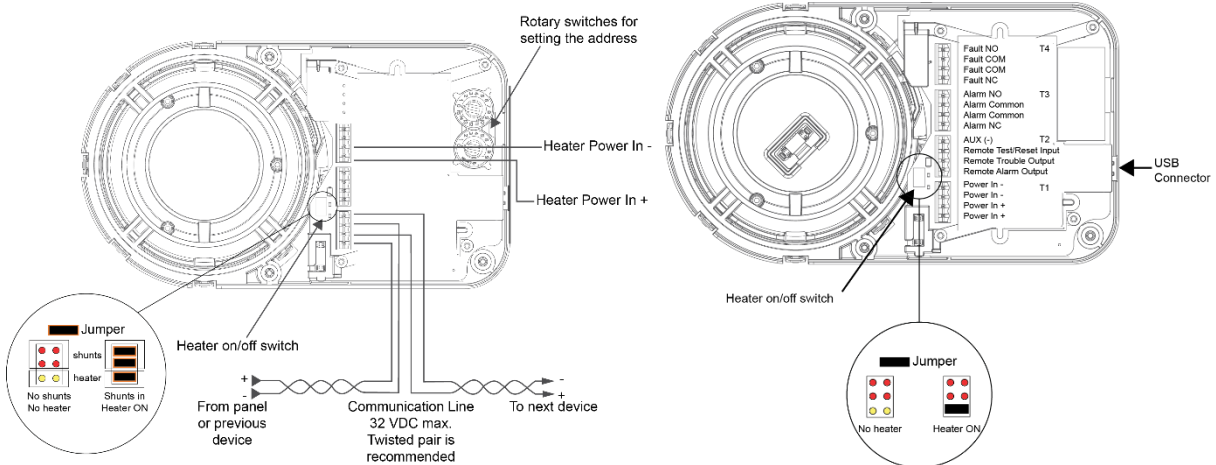
Wiring drawing errors in the Product Guides and Quick Start Guides of the concerned products has been discovered. Specifically, a jumper position switch between isolator settings and the heater setting in the wiring diagrams.

Wrong jumper settings:

The field correction, if the jumper(s) were applied at all, can simply be executed at a next service call.

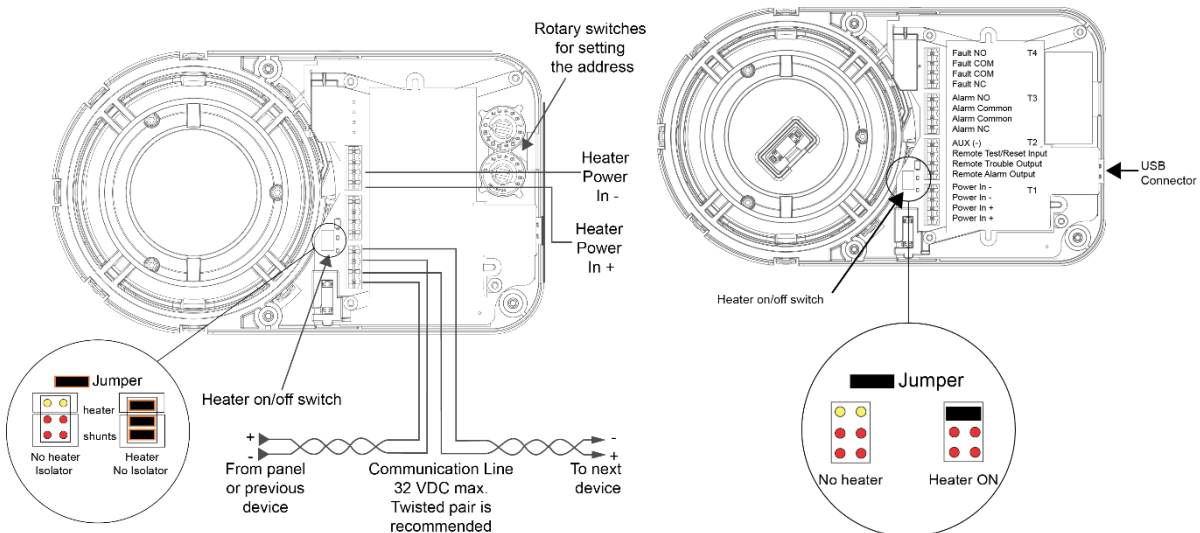
Correct jumper settings:

A corrective action on Product Guides and Quick Start Guides is already in place.
