VESDA VLI - TAMWORTH EQUESTRIAN CENTRE CASE STUDY

January 2022
Doc. No. 20840_03

This Case Study provides an overview of the replacement of the fire detection system originally installed at the Australian Equine and Livestock Events Centre (AELEC) which is situated in Tamworth, on the North West Slopes of New South Wales, Australia.

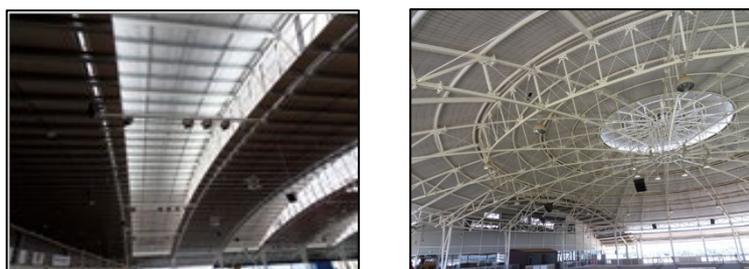
The point type detection system was deemed unsuitable due to the amount of dust and dirt present in this environment. The continued problems resulted in the client isolating the entire system throughout the Arena and Sales Ring / Warm Up area. This was due to the high level of nuisance alarms and automatic maintenance alerts (dirty detector alerts).

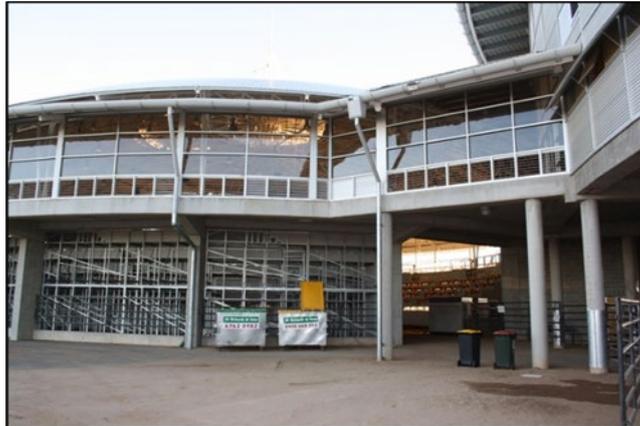
In order to meet the natural smoke ventilation requirements of the Fire Safety Engineering Report, the centre design is permanently open to natural atmospheric conditions. Metal louvers were part of the solid window sections on the first floor level, opened and closed according to the conditions. The open stock entrances to the Sales Ring / Warm Up Arenas, all influenced the original detection performance.

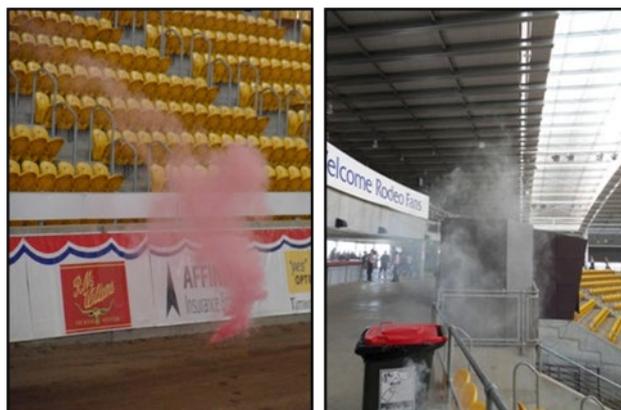
Smoke testing was carried out with representatives present from AELEC, Xtralis, Fire and Safety Technologies and Dynamic Fire, the installation contractor. Testing was conducted using cold smoke in several locations, including the Main Arena Performance Area, the Grandstand Area and the Warm Up Arena. These locations were chosen primarily to ascertain how the airflow moved within the complex.

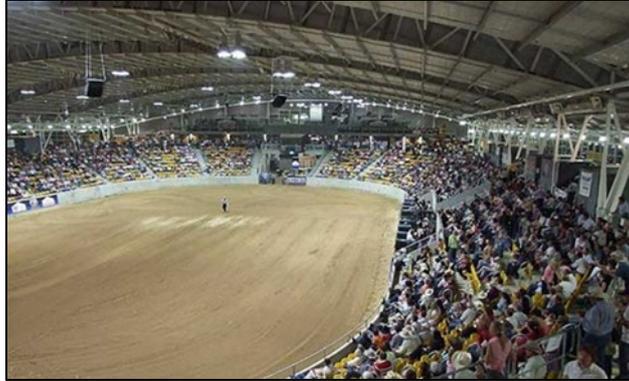
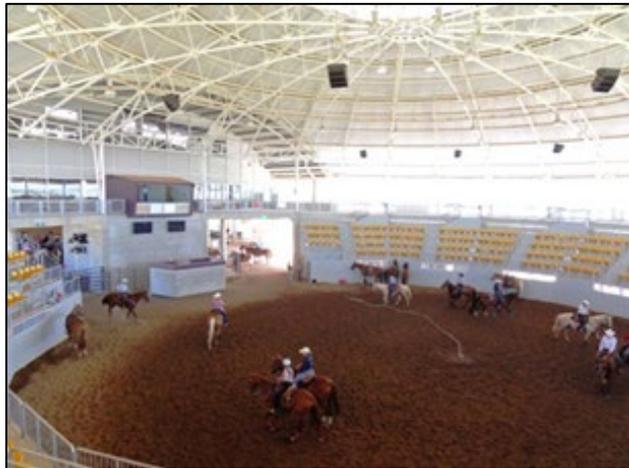
Six (6) VLI detectors were installed in the Main Arena, set out with three (3) detectors on either side of the building. The circular Sales Ring / Warm Up Arena had a single VLI detector installed.

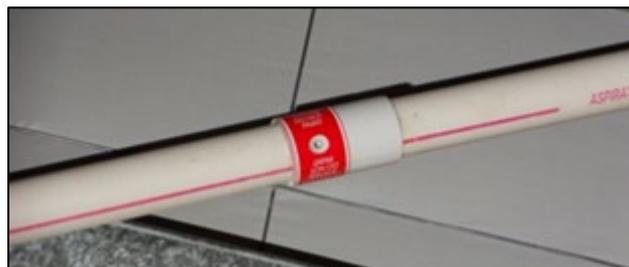
The sampling holes in the pipe networks were sized accordingly for the conditions using the VESDA modelling software program (ASPIRE). To minimize the dust contamination build-up, all sampling holes were countersunk.

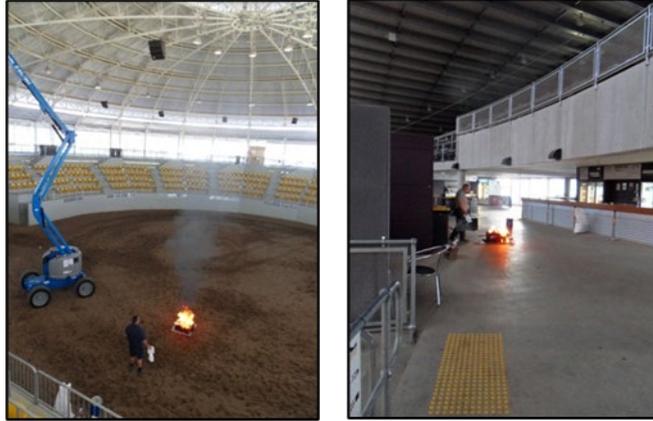
The Fire and Safety Technologies Consultant required comprehensive fire testing of the ASD systems at AELEC. This was to ascertain the detection and performance capability of each VLI detector. This was done by the creation of several "waste bin" type fires, those most likely to occur within the complex. The fires were of a size in the vicinity of 24 kw Avg, and were conducted at various locations in the Main Arena and Sales / Warm Up Arena.

Fires were a compilation of waste material, including cardboard, paper, cotton rags, plastics, diesel and timber.
